PRESIDENT'S ADDRESS

Waterproofing Membranes on Balconies with Lightweight Claddings

Leaking Basement - Waterproofing Repairs & Rectification

DOOR THRESHOLDS!!!

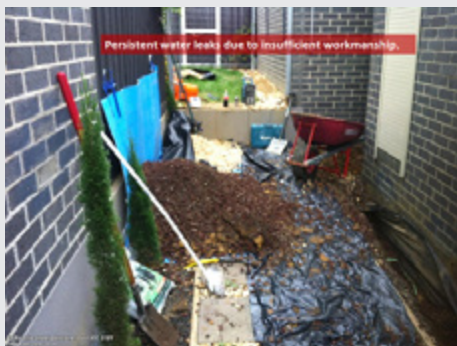
The owner of this new home had a swimming pool under his house in the basement, which contributed to the unfortunate problem of mold and stench coming from the foundations. The builder did the waterproofing himself – using plastic and product bought from a local hardware! It was a very tight situation; but our Team were fantastic with this job. The foundation was excavated and cleaned right down to the footings and then waterproofing application installed.

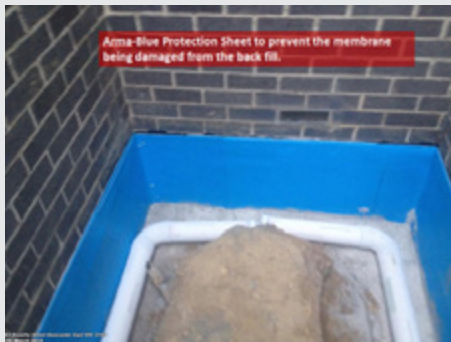
Arma-Blue Protection Sheet was then used to protect the basement waterproofing from being damaged by backfill.

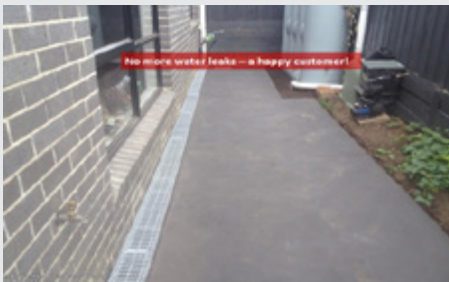
Team completing the front courtyard, entire rear yard, colour matched everything, and then reinstated.

Our client reported that after huge rains we had in Melbourne - basement was bone dry.

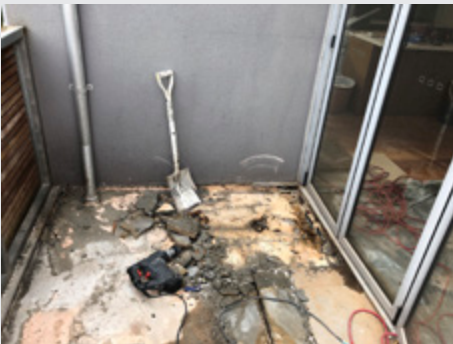
This door frame was sitting down on the tiled surface and water had been ingressing in for a very long-time causing destruction of structural timbers below and adjacent to the door frame.

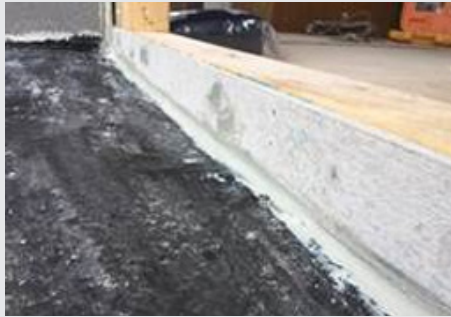
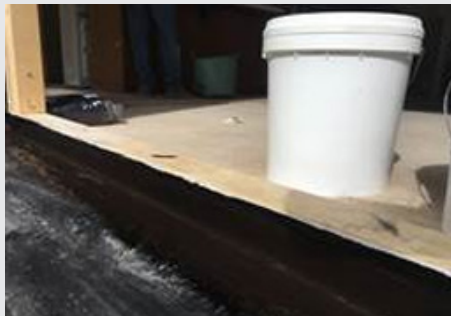
The outcome here was to remove the door frames (three in this job) – install a bottom plate and cement sheet upstand and detail that before the membrane was applied. This is the only way of ensuring a water-tight upturn below the door sill. Admittedly, being builders as well as waterproofers this

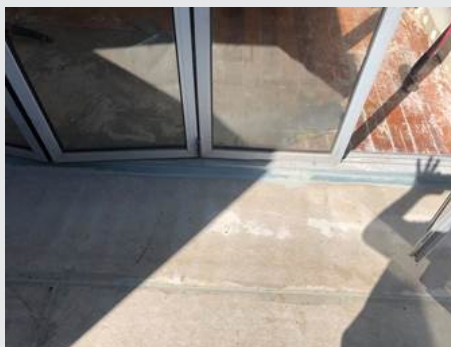
Another building design fault (which the

builder carried out !!) is the cladding the door frame reveals was a very poor detail as there no ventilation gap behind cladding and no room to insert cement sheet upturn, so other door upstands were created by using zincalume flashing embedded into fresh membrane to prevent the flashing rusting out in the future and then detailed on the front side.

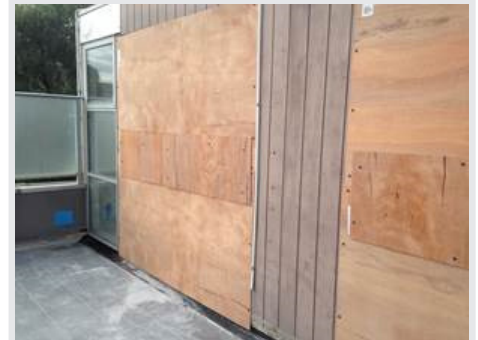
Now awaiting new (shorter) door frames to be installed (no extra head height to lift existing door frames) The message here is don't waterproof a job with low thresholds, you are just asking for a call back.
